May 19, 2023

Miguel Galvez, Facilities Manager
Fairlington Villages, A Condominium Association
3001 S. Abingdon Street
Arlington, VA 22206

SUBJECT: Report of Engineering Consulting Services - Egress Windows (Revised)
Fairlington Villages
Arlington, VA
FEA Project No. R01.2013.007922.FO17

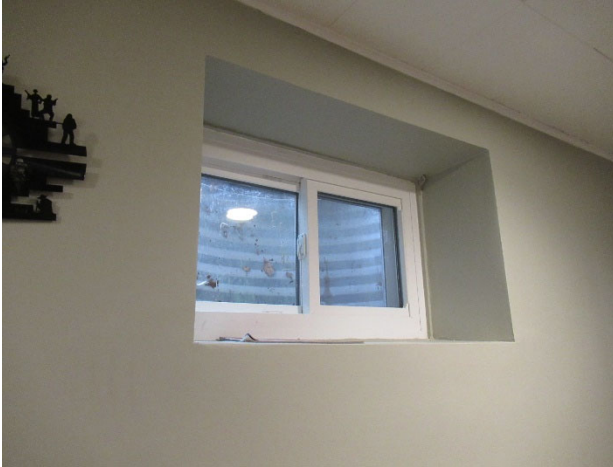
Exterior building walls consisted of brick masonry. Foundation construction varied and included a combination of cast-in-place concrete, concrete masonry units (CMU), and brick. Sliding windows were located near the top of the rooms observed with interior finish openings approaching 34 inches wide and about 20 inches tall, on average. Exterior openings at sliding windows were generally 36 inches wide and 25 inches tall. Window wells were a few inches wider than windows and constructed of concrete or galvanized steel. Window well height varied depending on the surrounding grade, and wells were covered with steel bars or plastic covers.

Photograph #1: Typical interior window opening

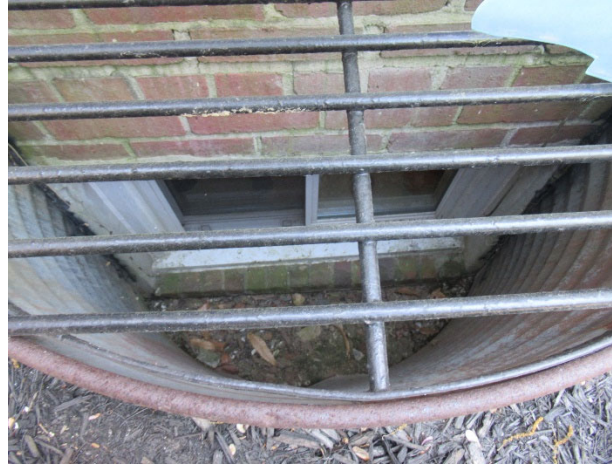
Photograph #2: Window well with galvanized steel and steel bars over top

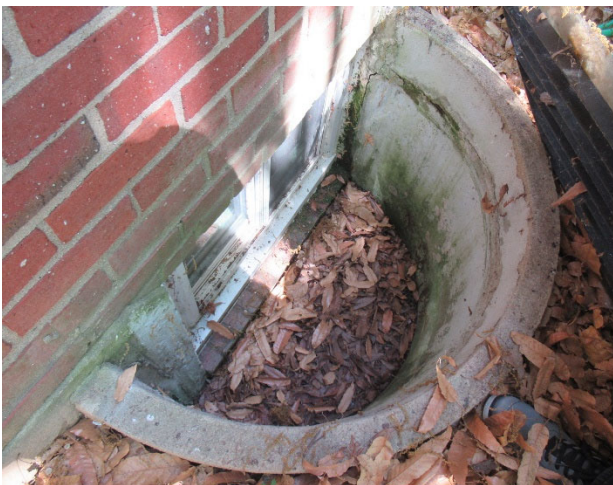
Photograph #3: Concrete window well

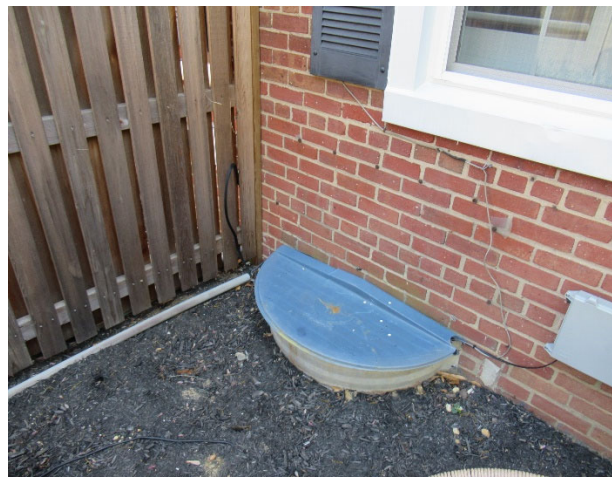
Photograph #4: Window well with plastic cover

- Drainage provisions do not appear feasible given the lack of existing below-grade provision to tie into and the relatively flat terrain in many areas. As such, window wells should be covered with a heavy duty, clear plastic cover to shed water away from the building and minimize water entry into the window well. As stated above, any covers should be able to be opened from the interior.

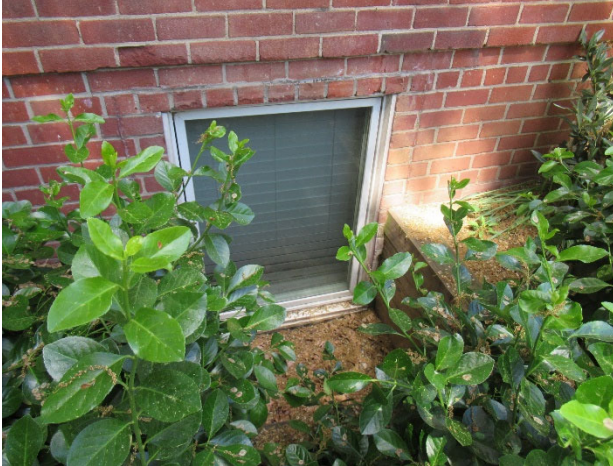
Fairlington Villages indicated that an egress window had previously been permitted for installation at a partially below-grade unit at 3004 S. Columbus Street. The egress window at 3004 S. Columbus Street was reportedly approved under a variance by the Board at the time of installation, and consisted of a single, side-hung casement window with a window well that was constructed of 6-inch x 6-inch wood timber totaling approximately 28 inches in height. The exterior masonry wall appeared to have been sawcut to enlarge the window opening and accommodate the casement window. The window well was

about 39 inches wide along the wall and extended 36 inches away from the window. The bottom of the well contained gravel and did not have drainage provisions; Fairlington Villages reported that water infiltration into the unit has been an issue at times. There was no cover over top of the window well.

Photograph #5: Egress window at previously approved location

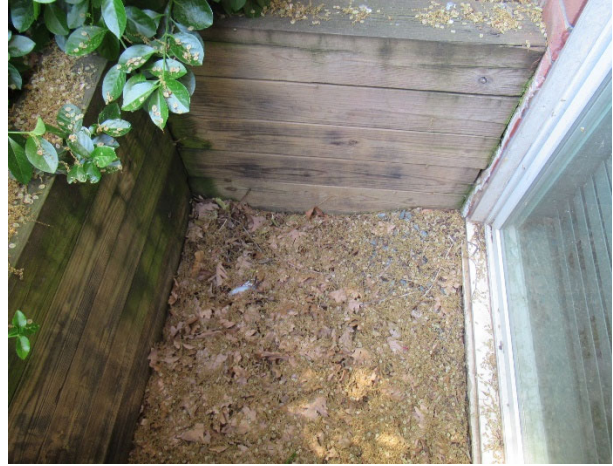
Photograph #6: Timber window well at previously approved location

- Window wells are to be constructed with galvanized steel. They should extend a minimum of 8 inches below the bottom of the windowsill and 3 inches above surrounding grade. We understand the appearance of the timber window well construction at 3004 S. Columbus Street is not preferable.
